**REPORT NUMBER: 301-MGA-2009-010**

**SAFETY COMPLIANCE TESTING FOR FMVSS 301R  
FUEL SYSTEM INTEGRITY – REAR IMPACT**

**GENERAL MOTORS CORPORATION  
2008 CHEVROLET EXPRESS 2500 WORK VAN  
NHTSA NUMBER: C80114**

**PREPARED BY:  
MGA RESEARCH CORPORATION  
5000 WARREN ROAD  
BURLINGTON, WI 53105**

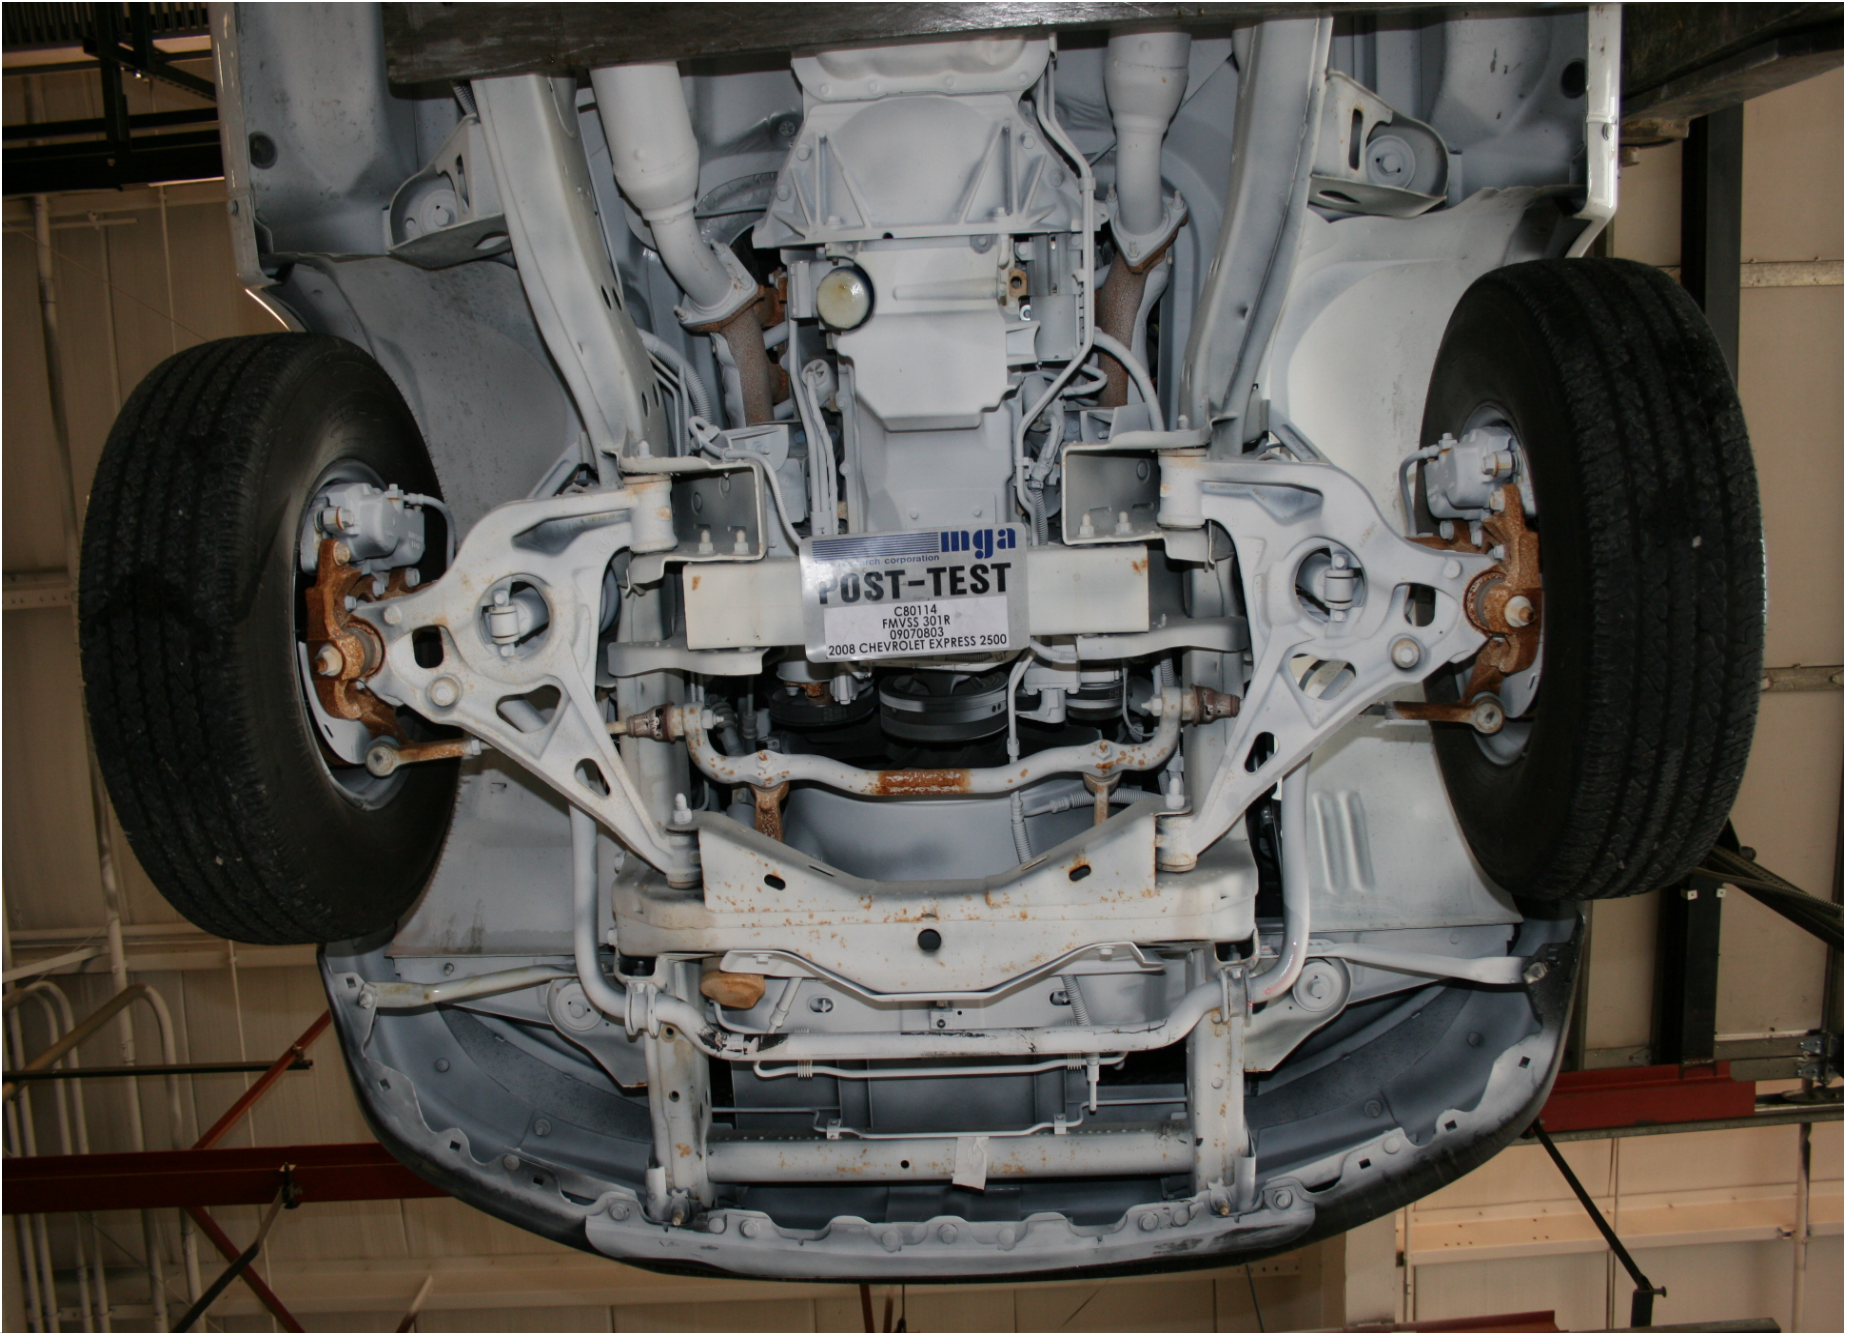
A-24.

Post-Test Underbody View 1

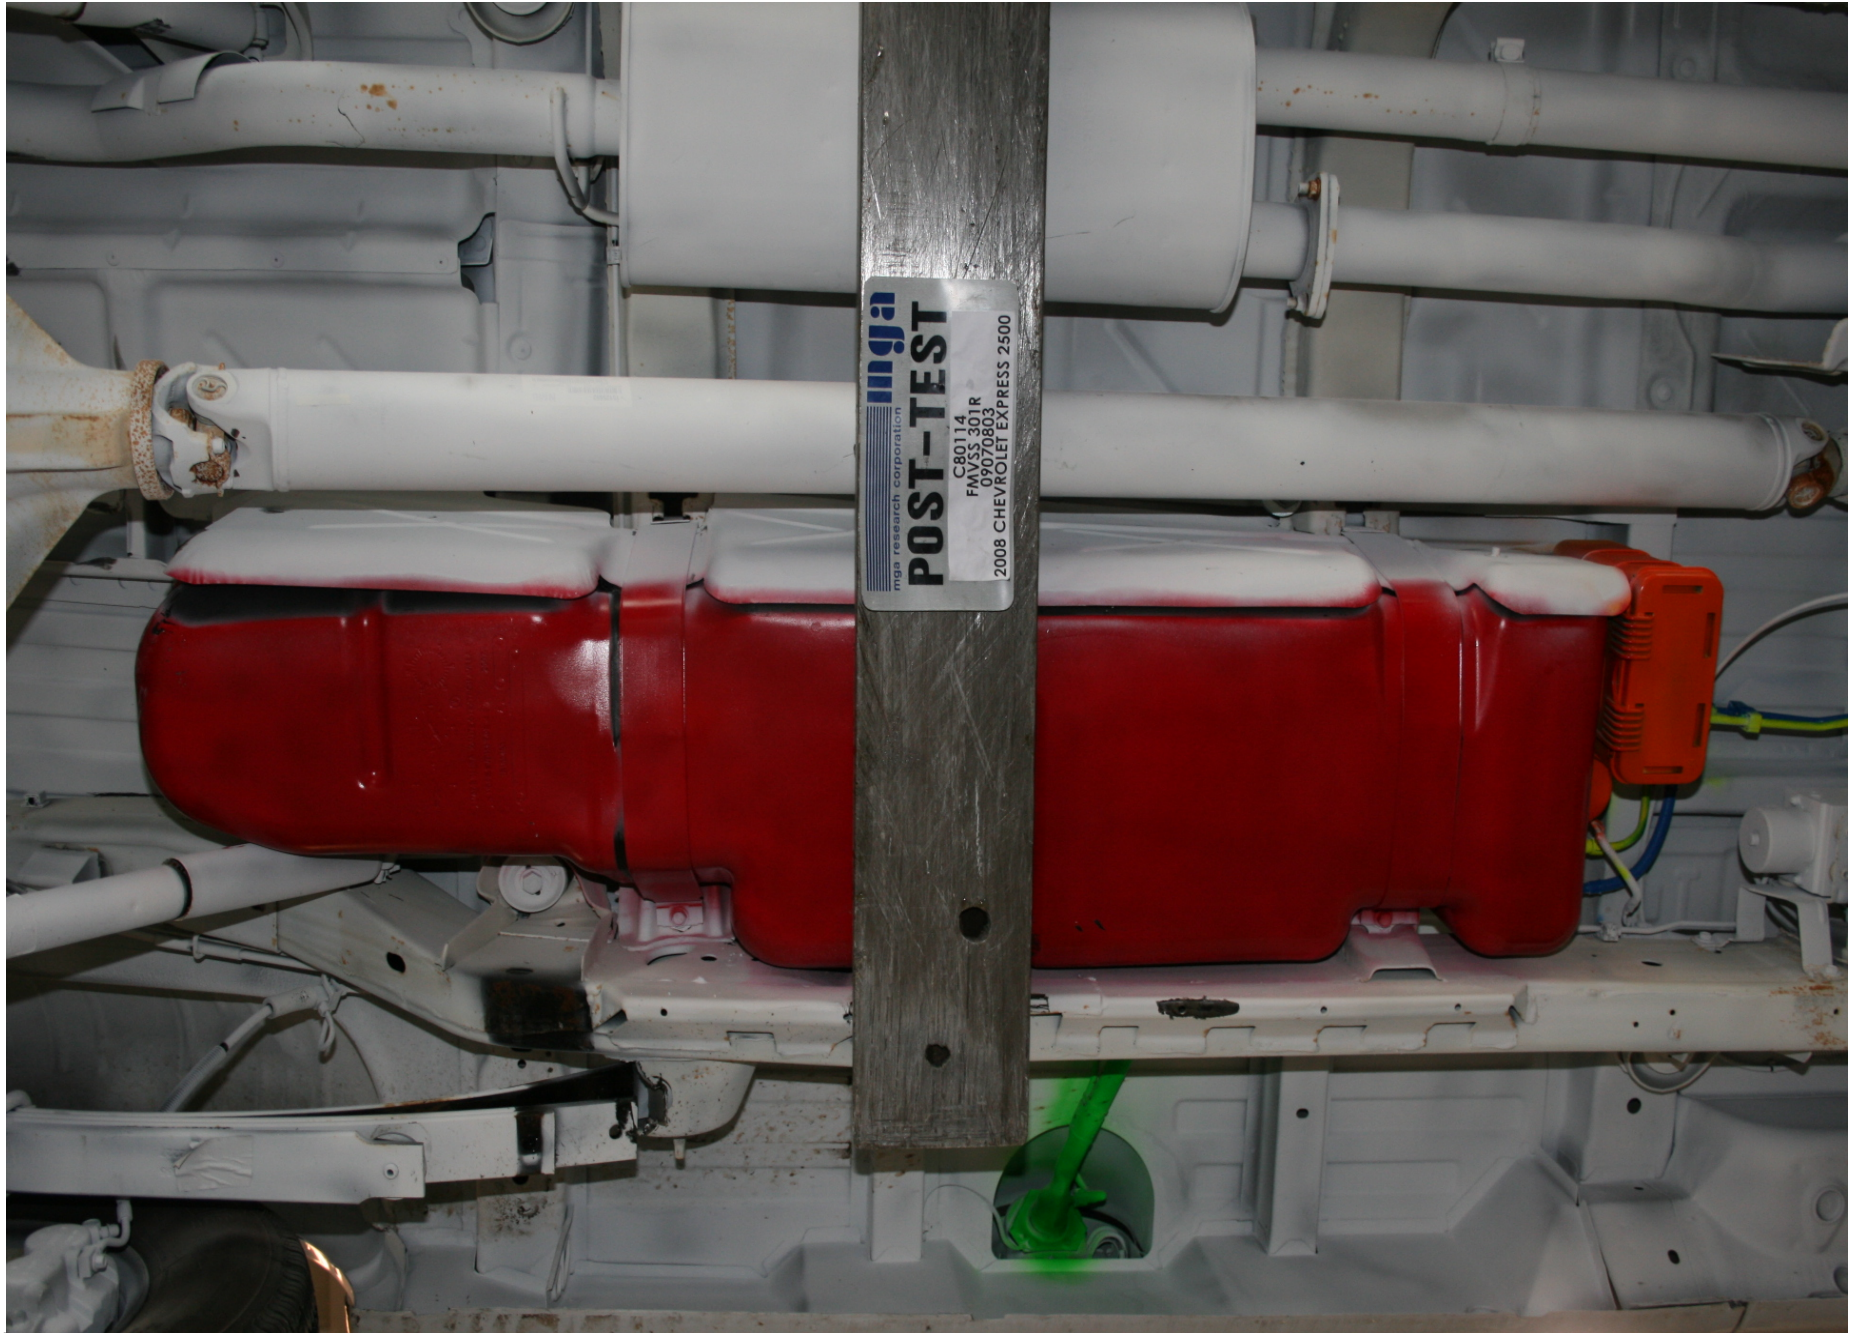
Post-Test Underbody View 2

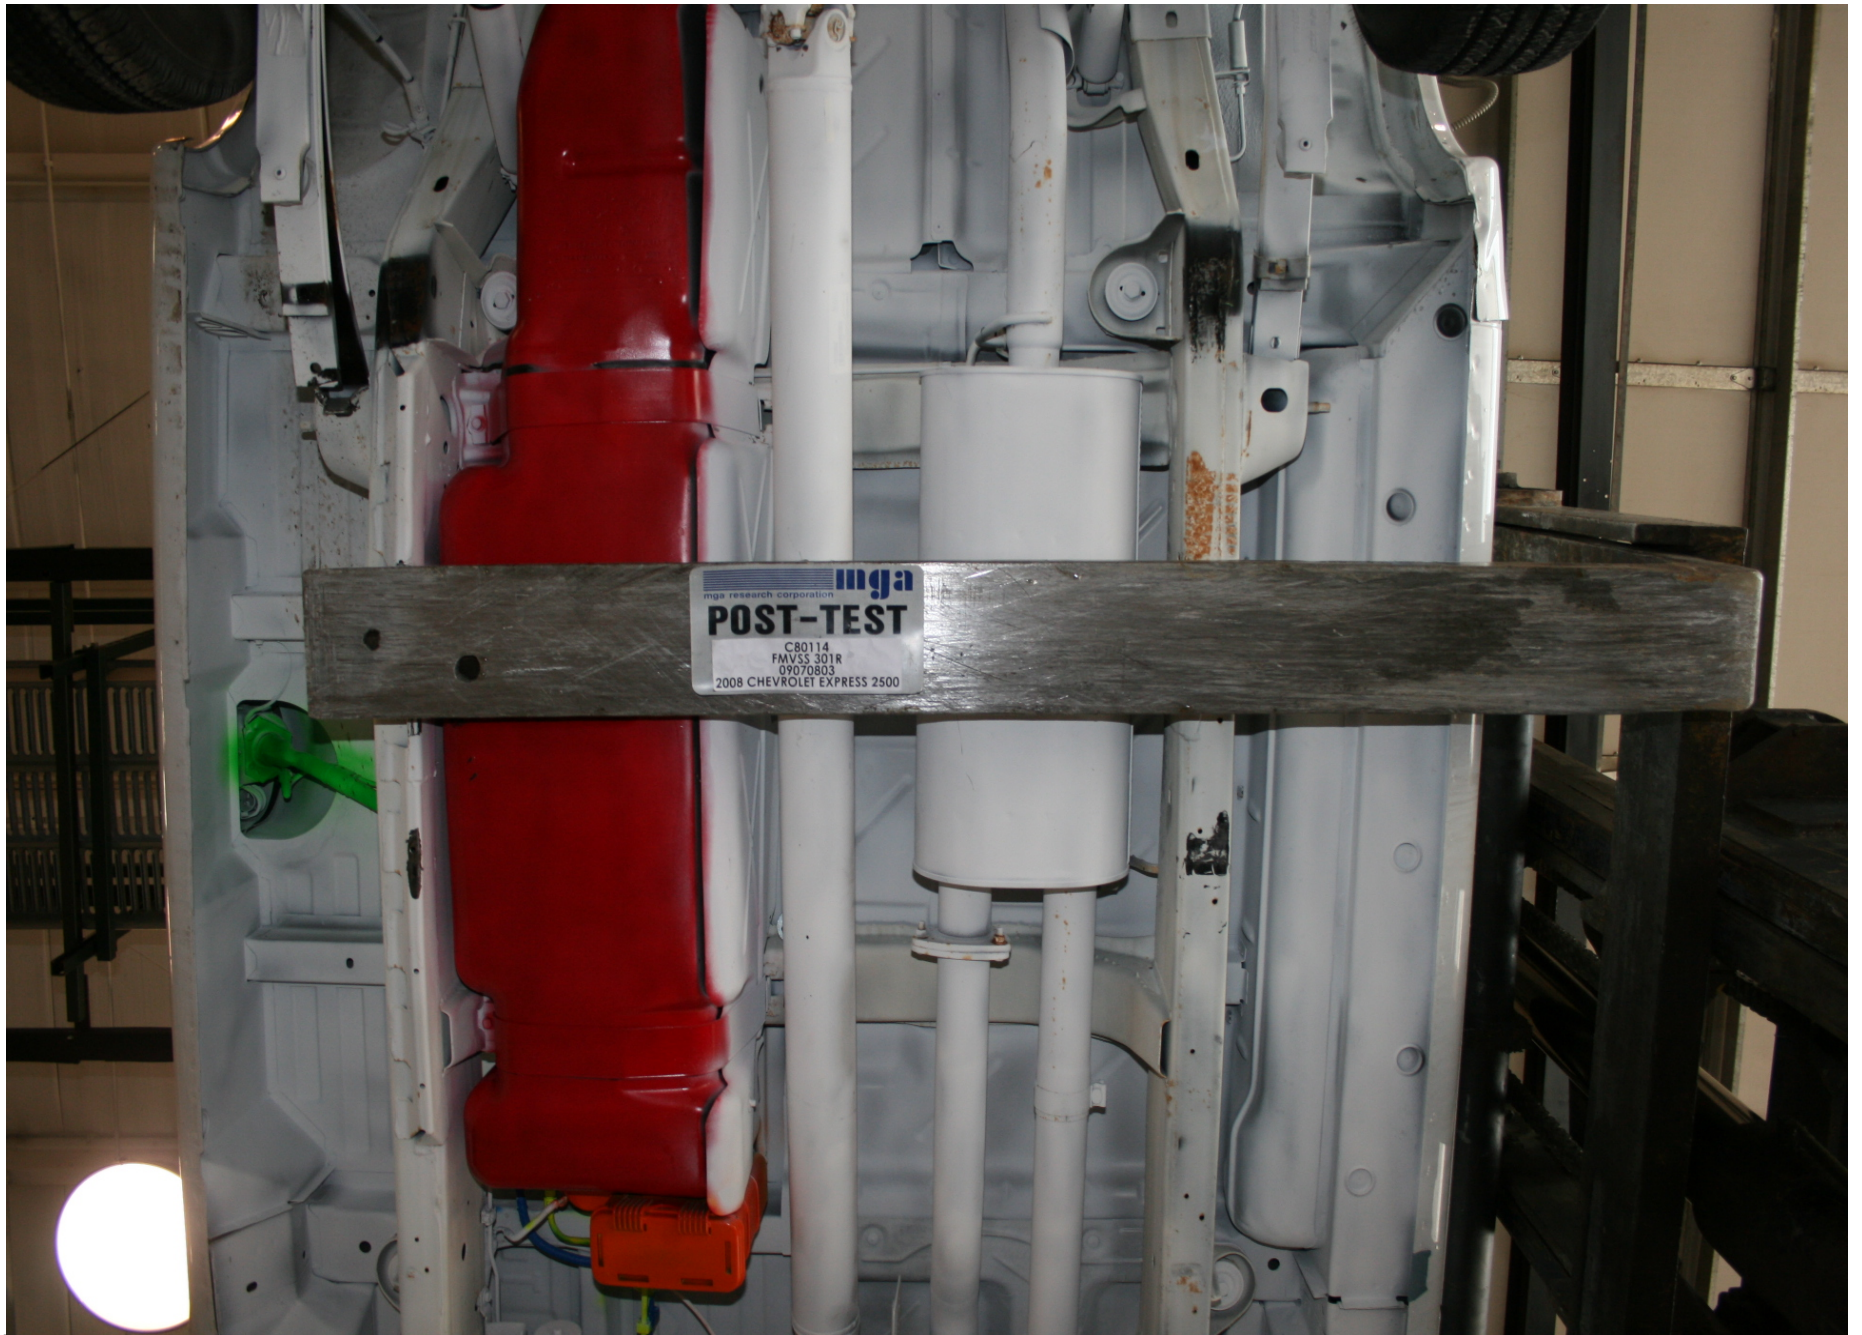
Post-Test Underbody View 3

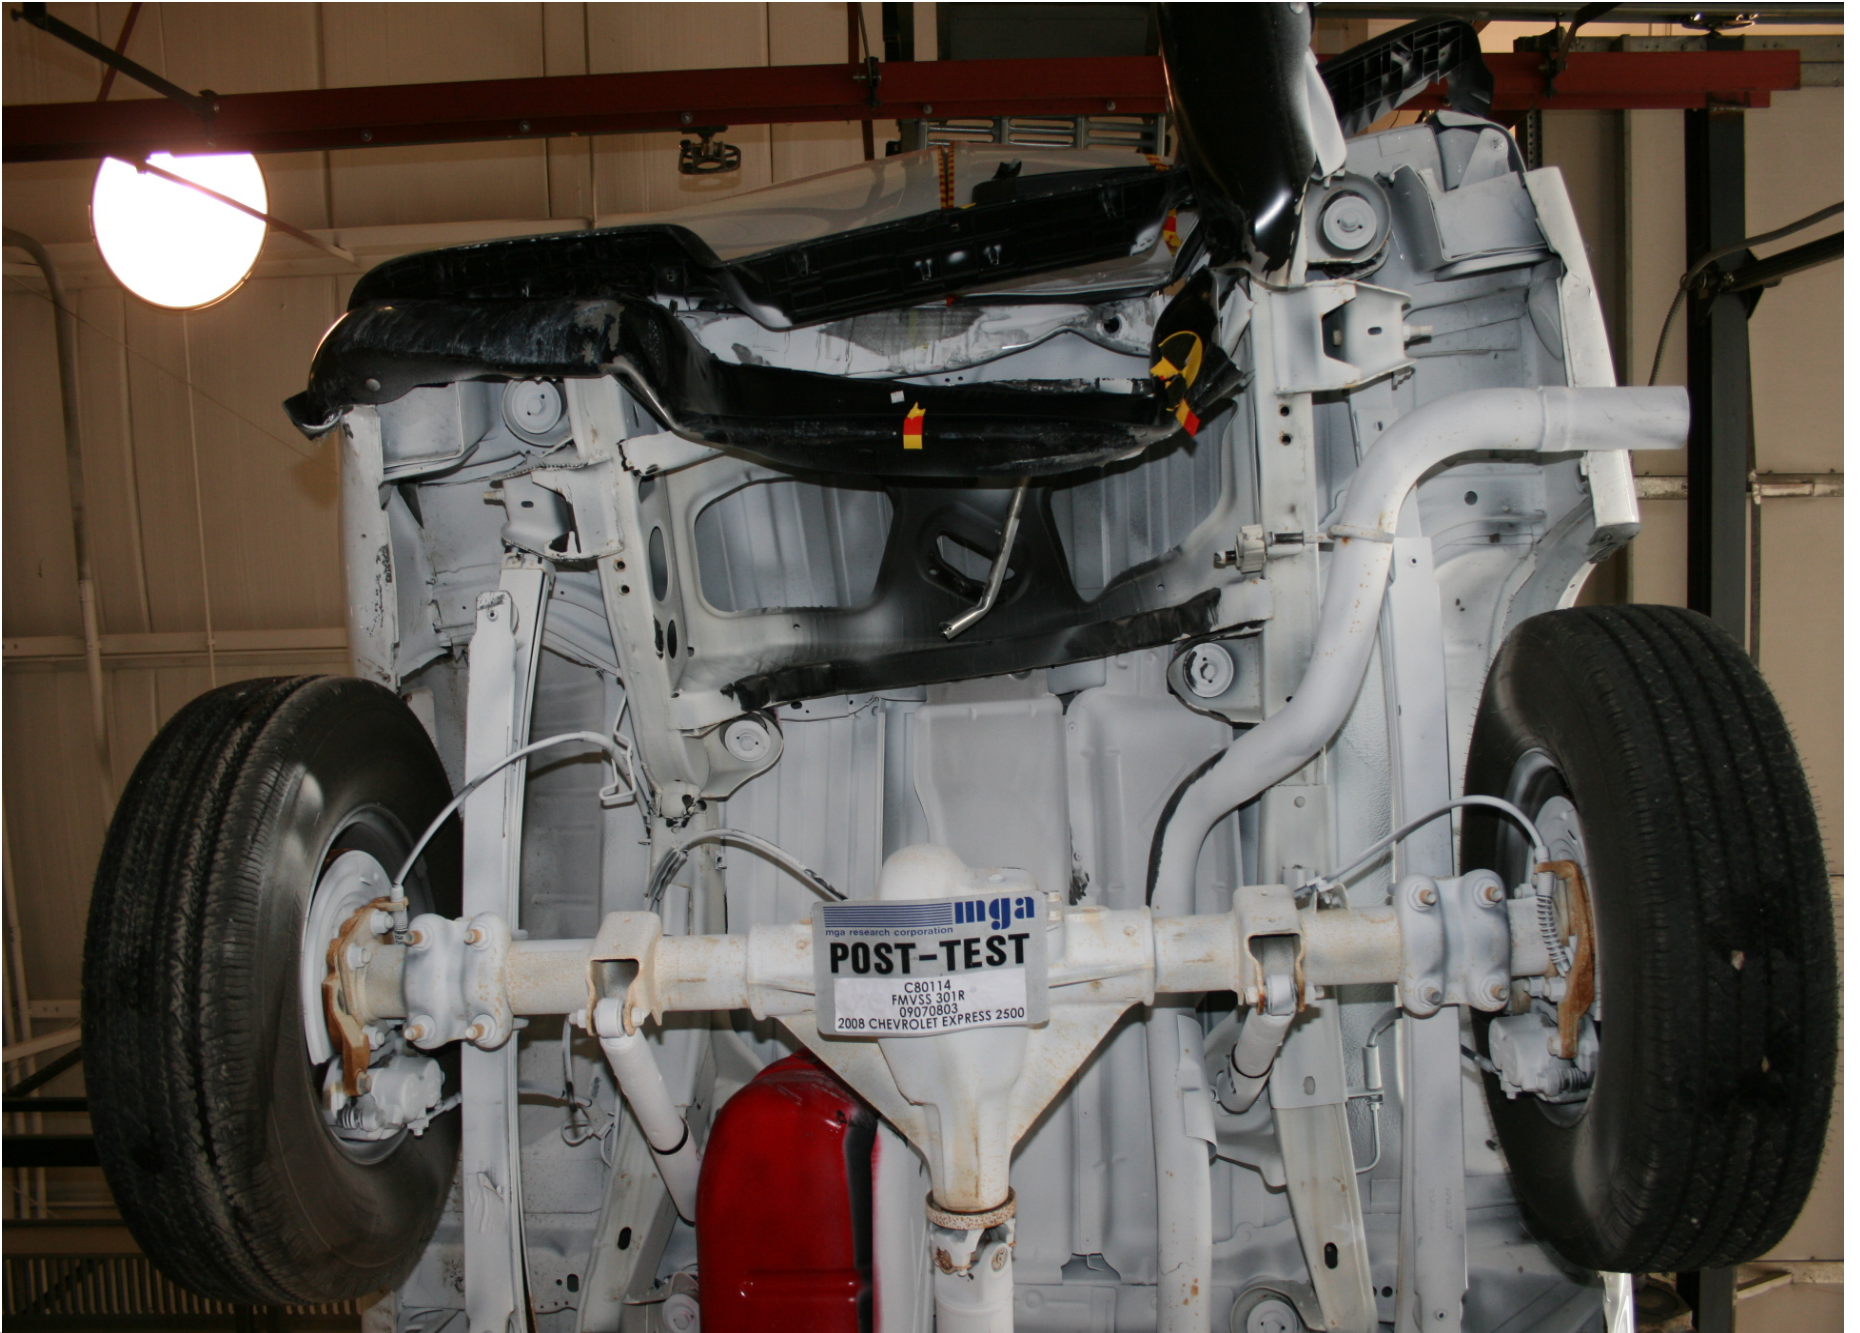
Post-Test Underbody View 4

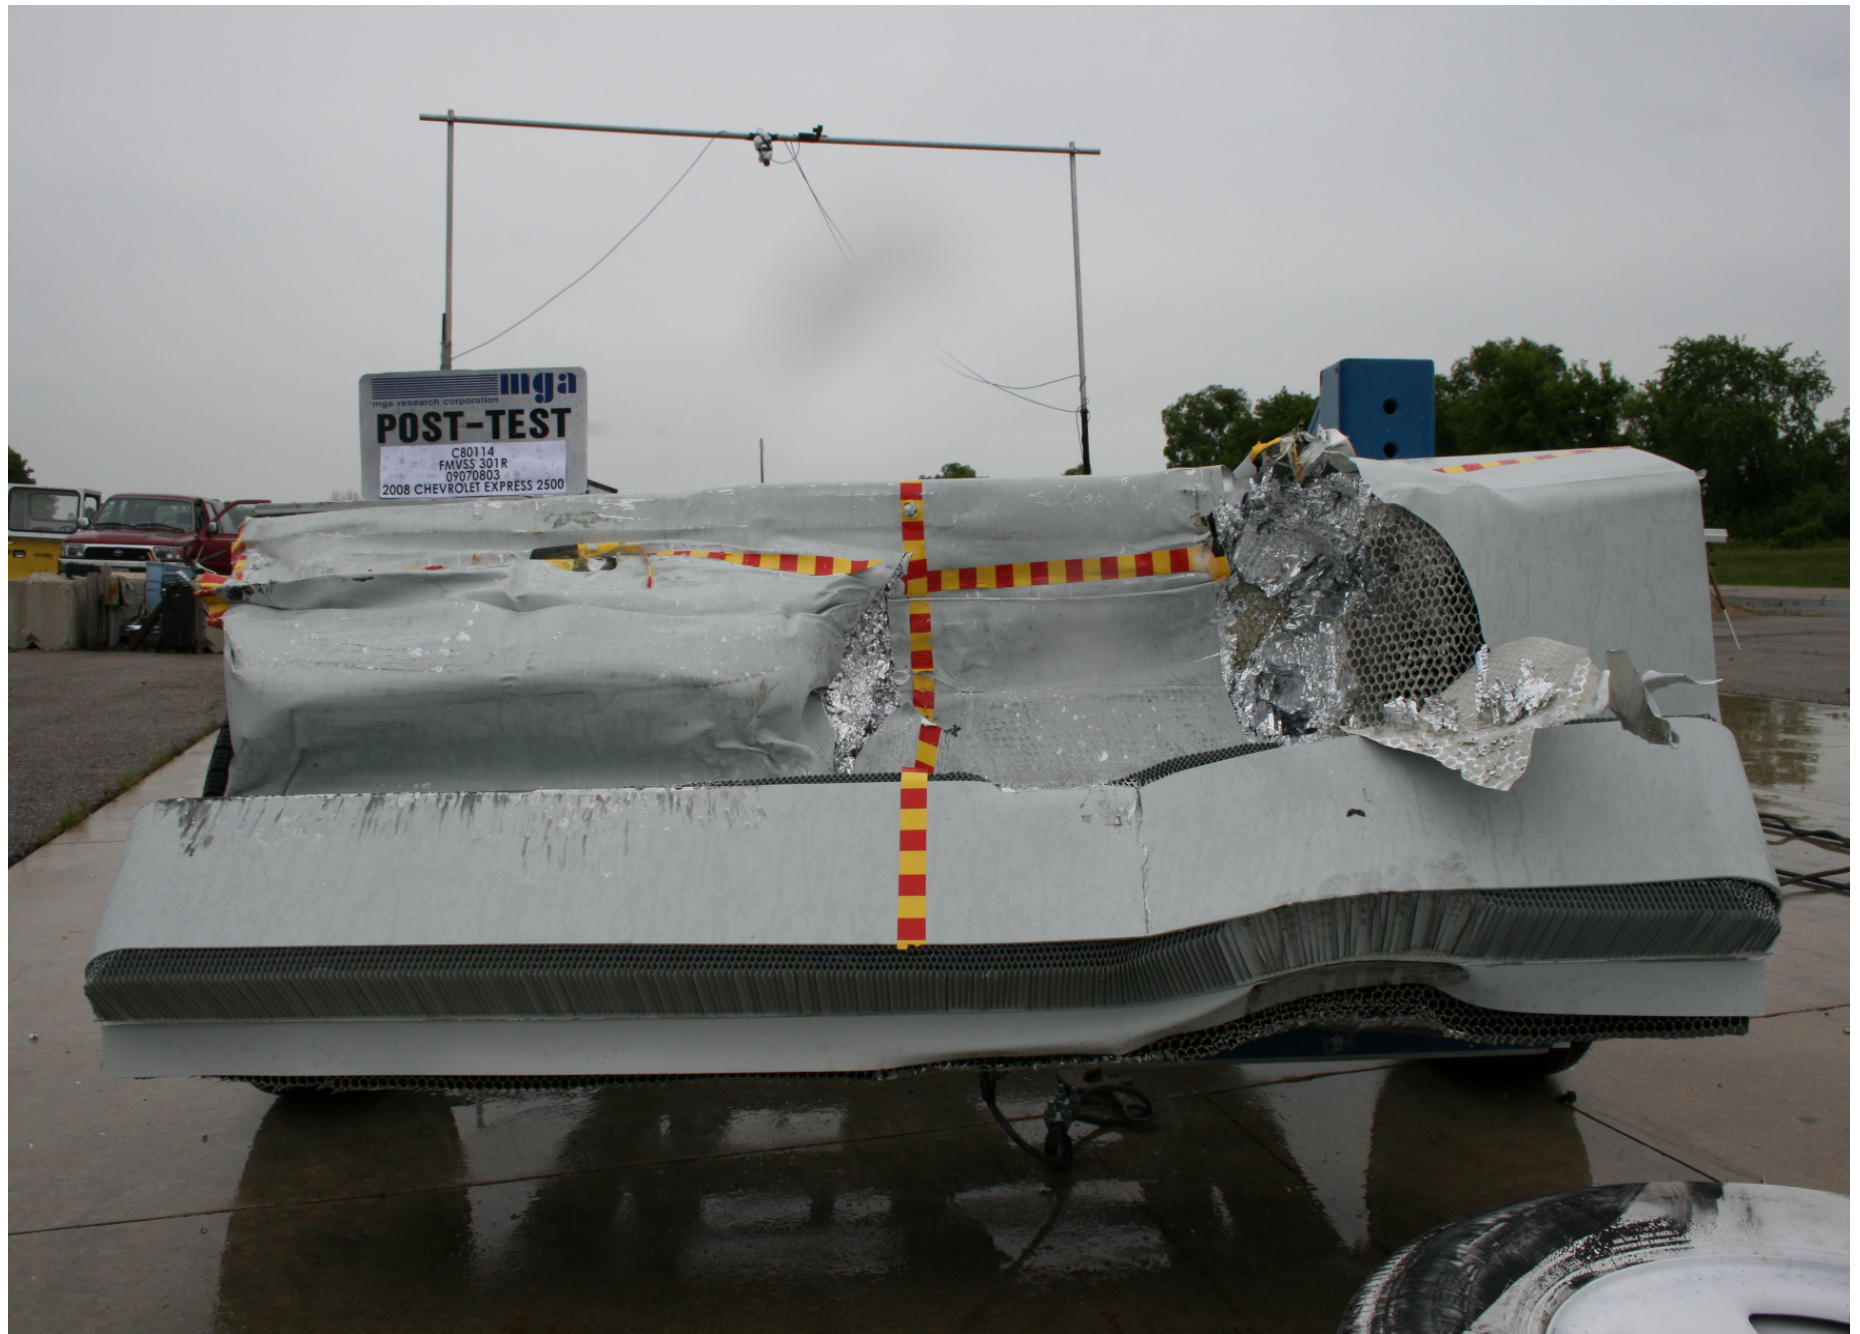
Post-Test Front View of MDB

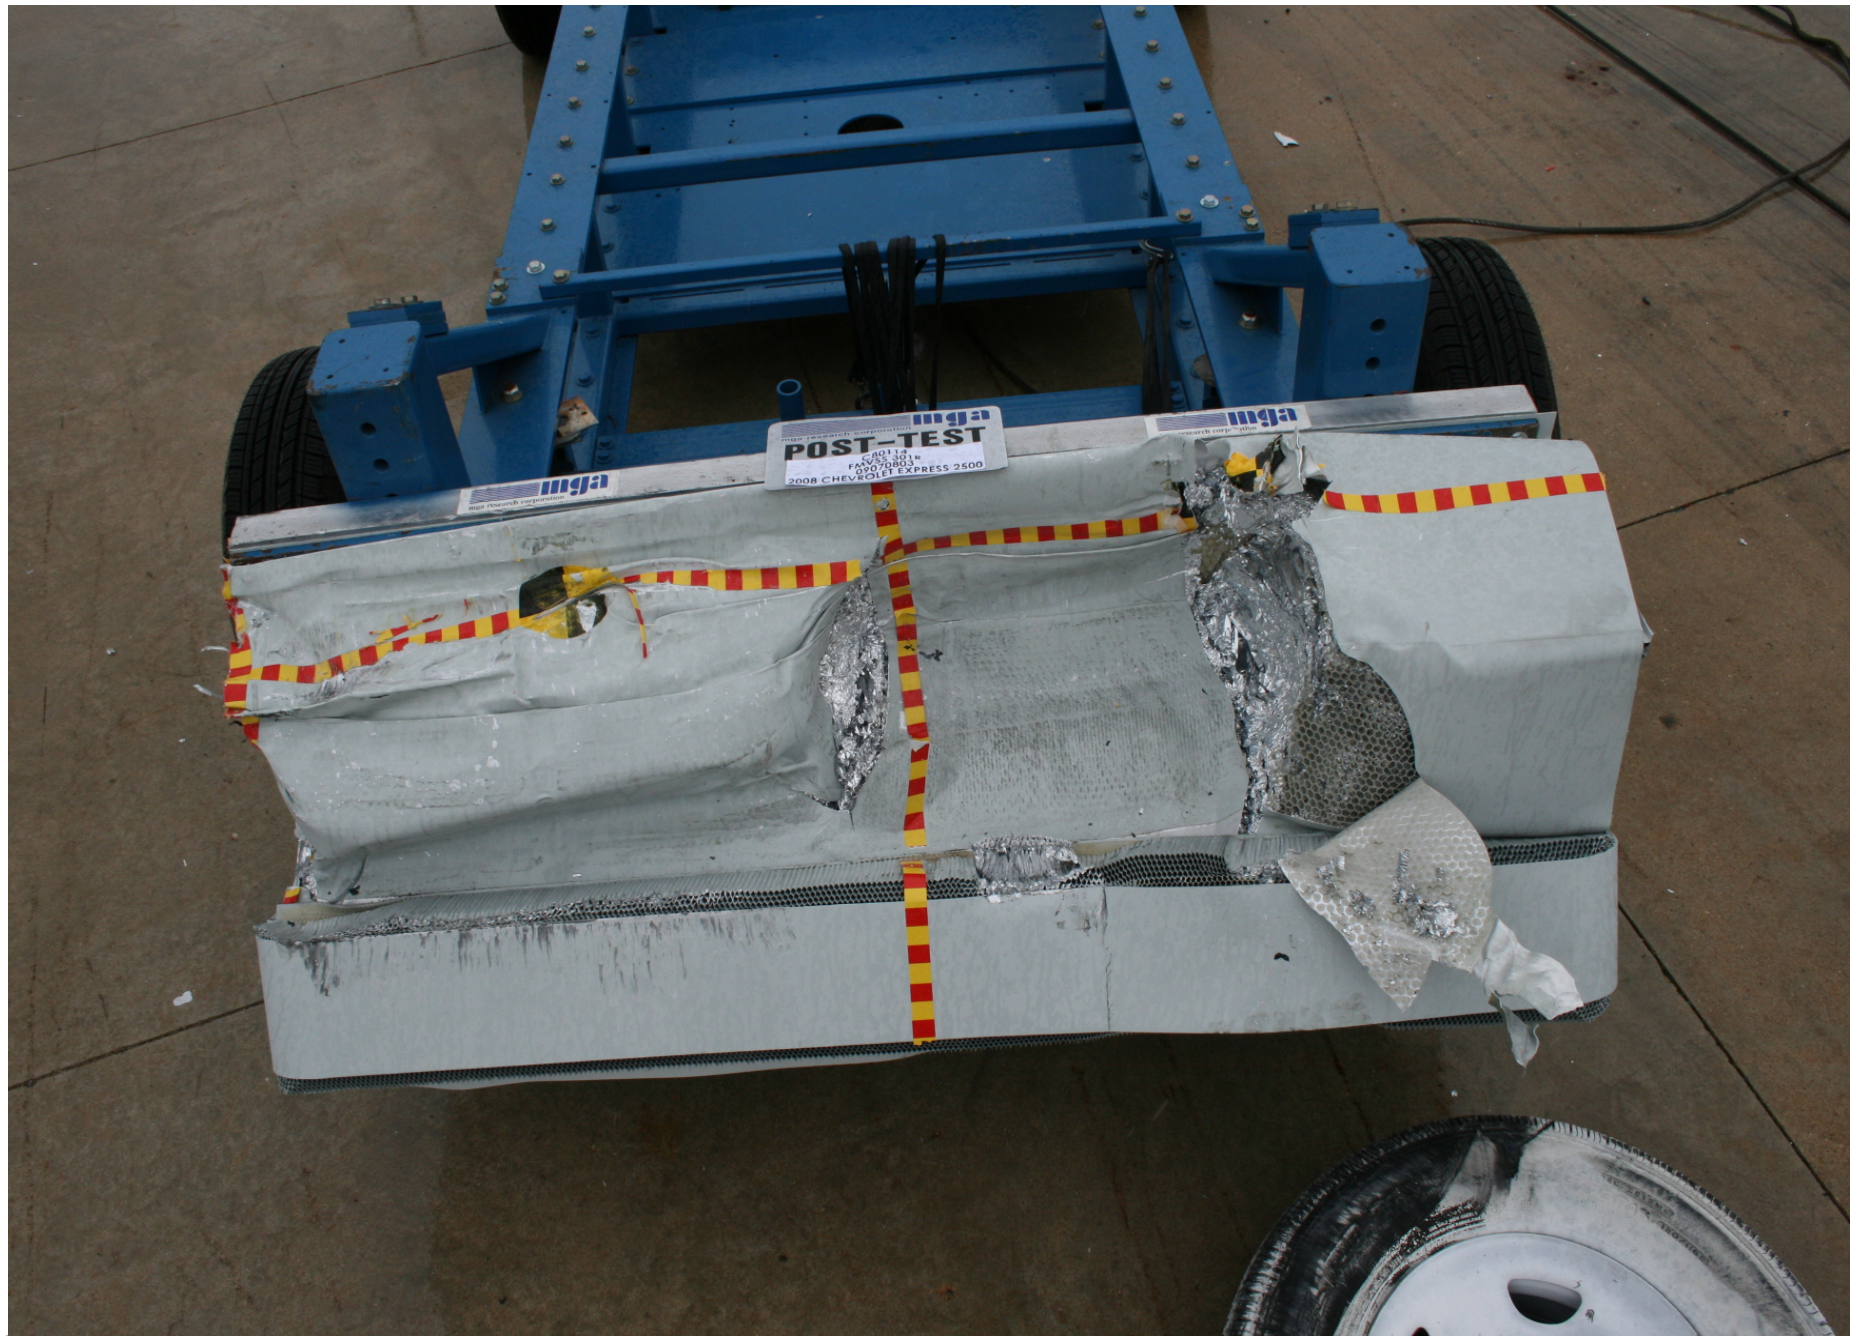
Post-Test Top View of MDB
